# Implications and Ramifications of Engineering Design of Field Joint for Space Shuttle: STS 51-L<sup>1</sup>

Akila Sankar, Emory University

Chetan S. Sankar, Auburn University

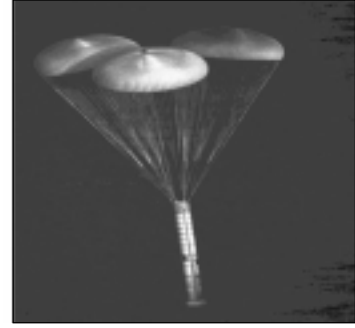
**Figure 2: SRB aided in its fall to the earth by parachutes**

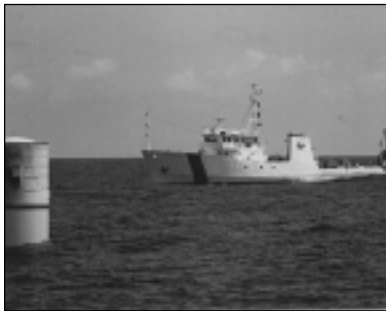
**Figure 3: SRB lands in the ocean and is retrieved by ship**

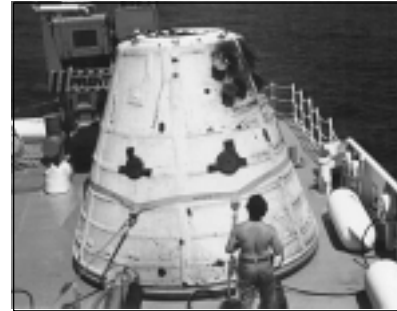
**Figure 4: The Frustrum of the SRB is loaded on to the ship**

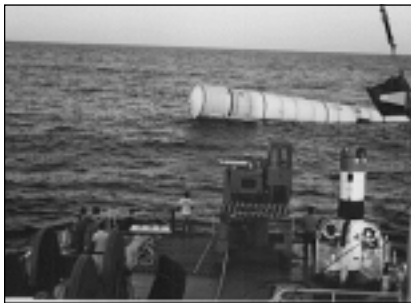
**Figure 5: The body of the spent SRB is loaded on to the ship**

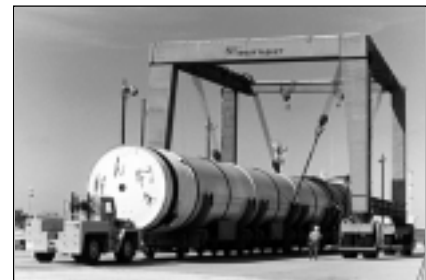
**Figure 6: The spent SRB is loaded on to the ship to be transported back to the manufacturer**

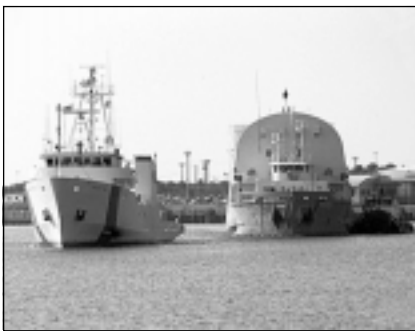
**Figure 7: The spent SRB is transported back to the manufacturer by a special vessel**

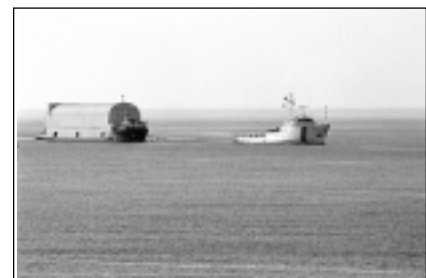
**Figure 8: The spent SRB reaches the manufacturer to be checked and readied for next mission**
